HOUSATONIC RIVER BASIN  
WASHINGTON, MASSACHUSETTS

WASHINGTON MOUNTAIN LAKE DIKE  
MA 00319

PHASE I INSPECTION REPORT  
NATIONAL DAM INSPECTION PROGRAM

DECEMBER 1979

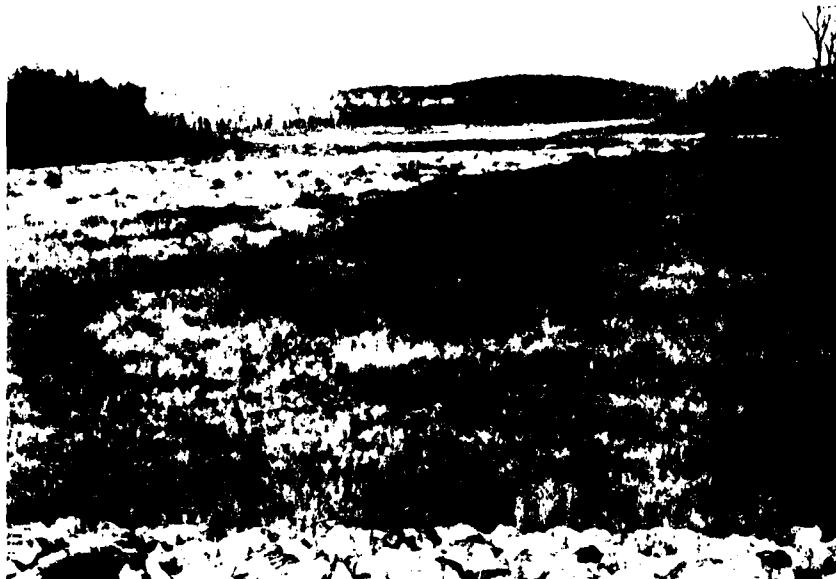
The top of the dike has been traveled upon by vehicles and wheel ruts have developed. The ruts contain rainwater and continuous use as a road has caused erosion.

Photo #5 View of dike  
crest looking westerly  
from left abutment.  
Note wheel ruts and  
ridges.

foundation drain system, clean out the sand and gravel from the culvert under Navin Road, repair top surface of the dike to prevent further erosion from vehicle traffic and develop a formal written emergency flood warning system.

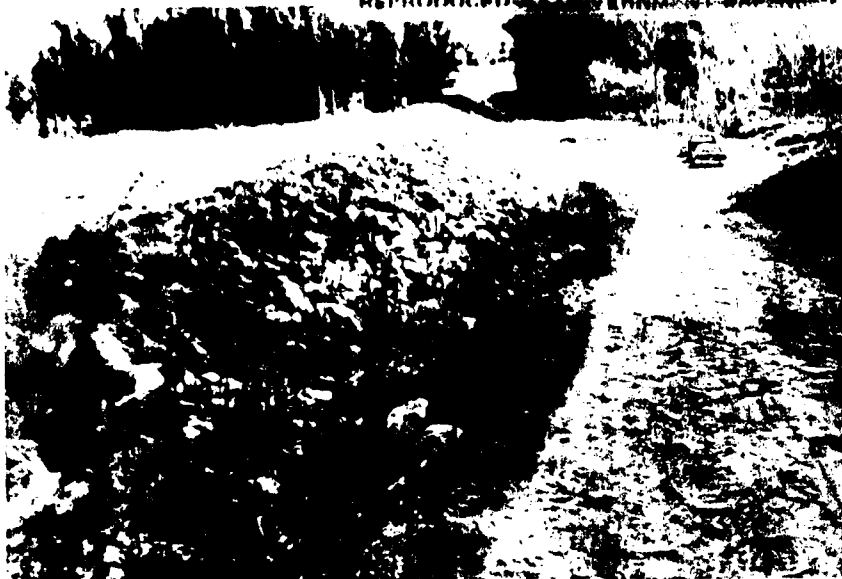
Photo #1 Overview of downstream side of dike looking easterly from right abutment

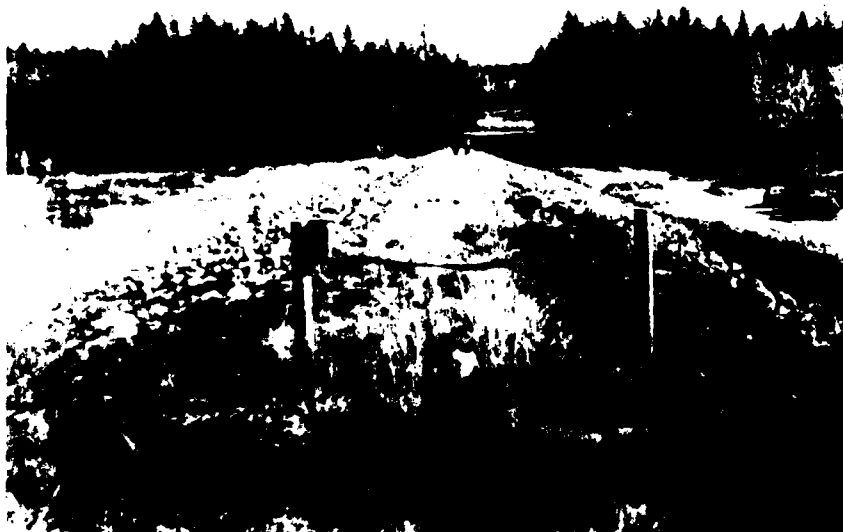
Photo #3 Overview of dike crest looking easterly from right abutment
